Product Assurance on the XMM Project

J.P. van Dooren

XMM Project, ESA Directorate for Scientific Programmes,
ESTEC, Noordwijk, The Netherlands

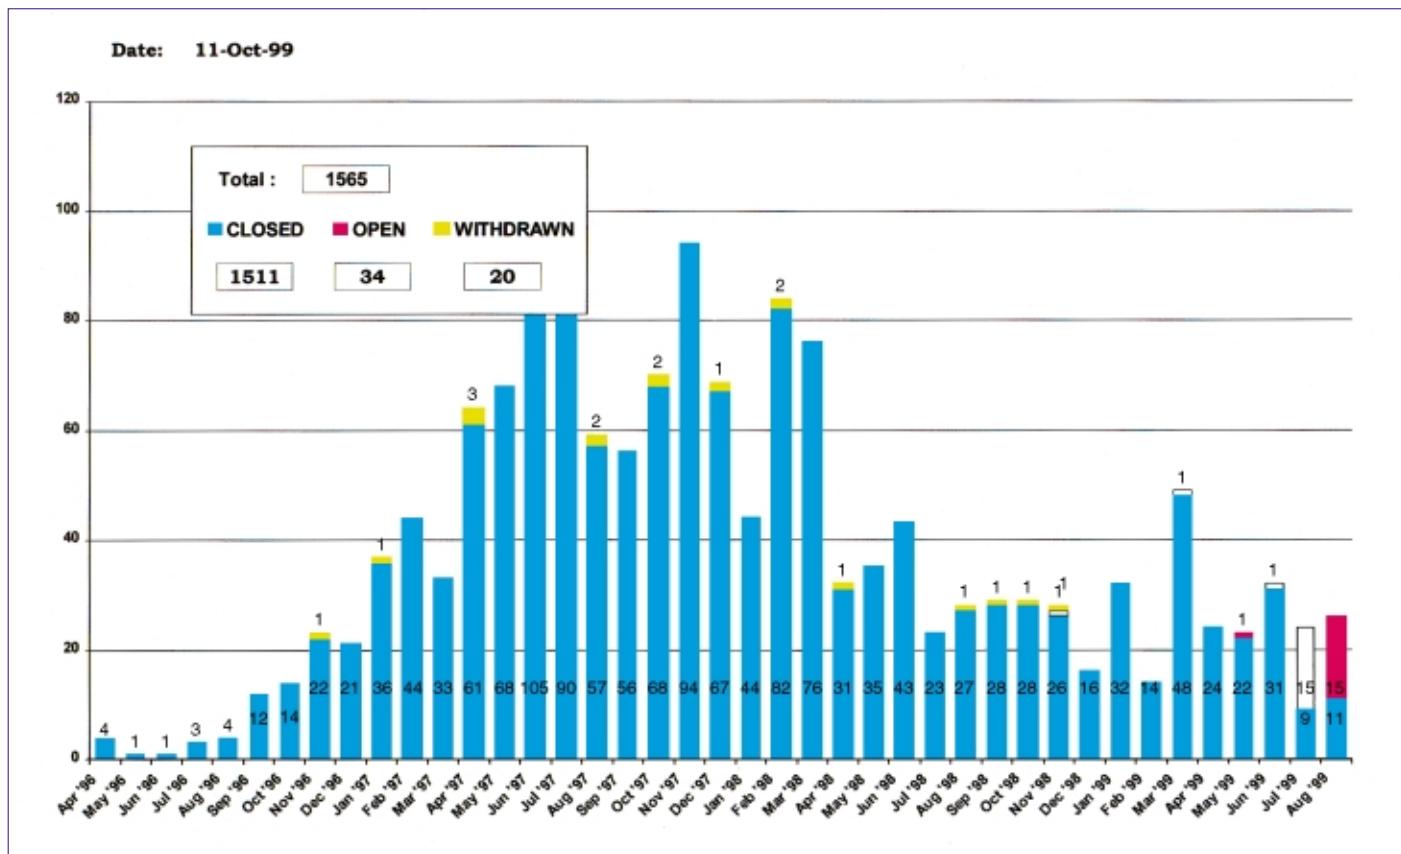
Figure 2. History of major XMM non-conformances

XMM had to deal with a number of non-conformances, as chronicled in Figure 2. Minor NCRs were handled at local level, while major ones involved the Prime Contractor, with the ESA PA and specialised project engineers maintaining an overview and taking action whenever necessary. This delegation of quality handling has resulted in very efficient and fast NCR processing. All NCRs that are still open,

relating mainly to operations software and database issues, will probably be closed before the Flight Acceptance Review. Waivers have been handled by a Configuration Control Board (CCB), both at the Prime Contractor and at ESA. This approach has prevented 'creeping design changes'.

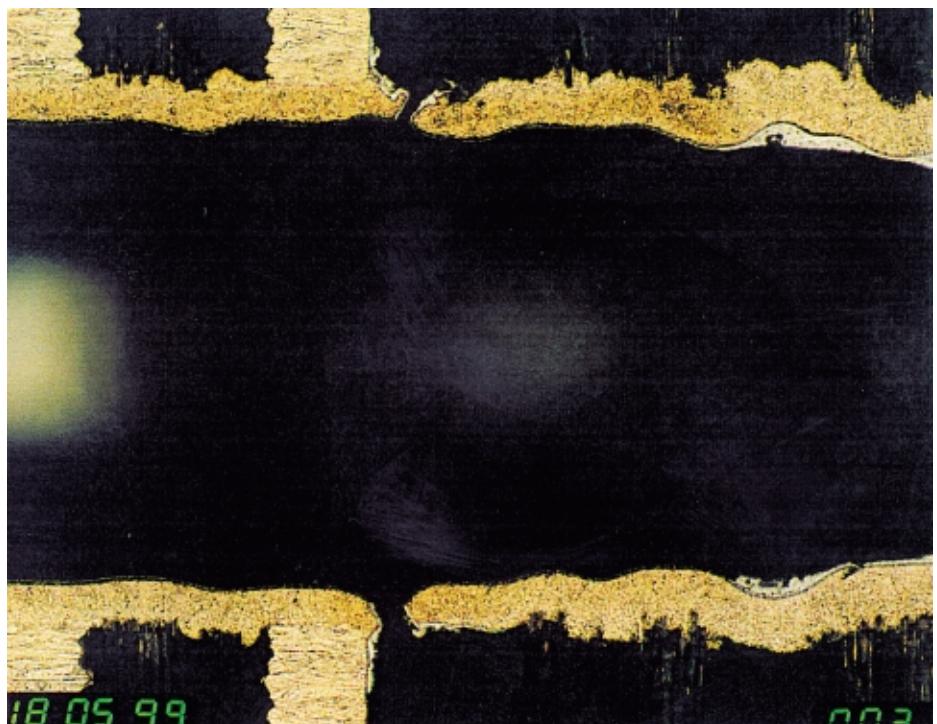
A serious problem occurred during electrical testing (SVT-1): the CDMU showed bootstrap loading errors in some parts of the memory, on both redundant units. Suspect memory chips were removed and tested at ESTEC, but proved fault-free. The most likely cause was one or more open circuits in the multi-layer printed-circuit boards (PCBs). These were sent to ESTEC's laboratories for cross-sectioning. Two open-circuited 'vias' (plated-through holes) were discovered, which explained the failures (Fig. 3). More than fifty vias were cross-sectioned at ESTEC and at the PCB manufacturer, without discovering any further opens. The root cause of the problem was

traced back to the manufacturing process. During the cleaning of PCBs with very fine vias, the procedure called for a powerful vibrator to be switched on, in order to remove any air bubbles from the holes. This had been forgotten for the XMM and Integral flight boards, which were in the same lot. For the spare-board lot, the vibrator had been switched on. These boards were thermally cycled to simulate the reflow soldering process, and thoroughly visually inspected, and they were fine. The boards were completely assembled, environmentally tested, and passed without problem. They have been used since then and passed acoustic testing without a glitch.

Figure 3. Detail of a via (plated-through) hole from a failed area, showing the gap in the barrel copper

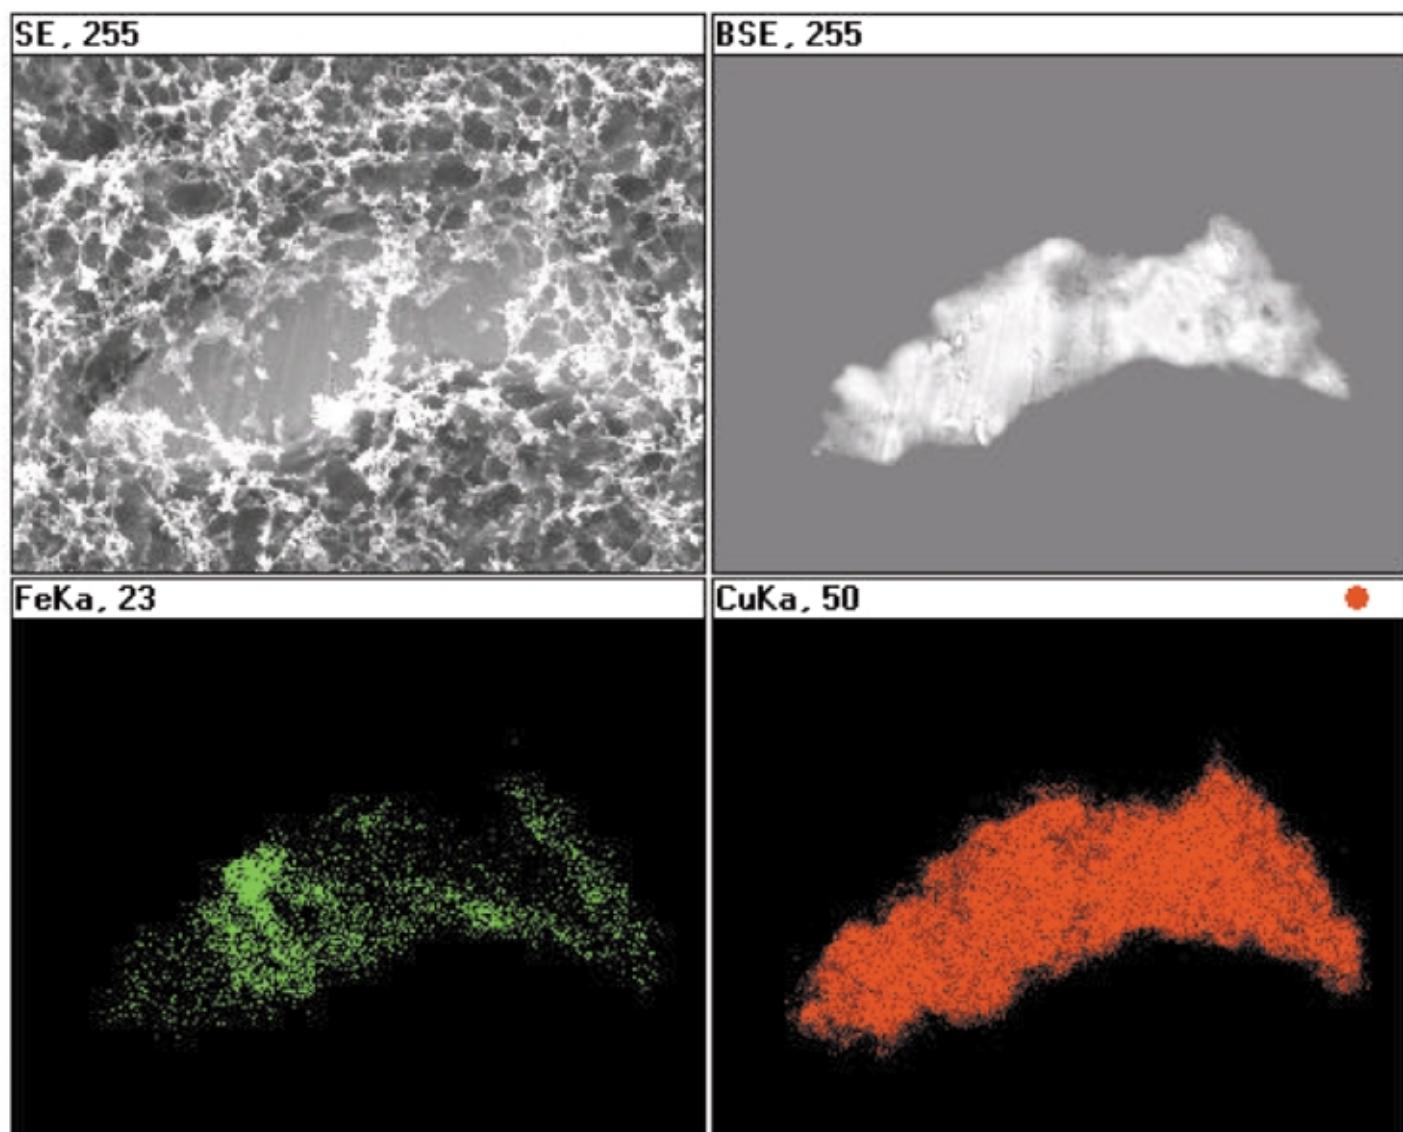
The most serious cleanliness problem occurred with the EPIC p-n camera's flight model. Noisy signals were read from part of the 4-inch wafer CCD, which is not passivated. At first, it was believed that a coronal discharge due to ice formation was responsible, caused by insufficient vacuum during cooling down. We used the fault-tree technique to identify all possible (imaginable) causes of failure, and possible contamination was listed a number of times. The ESTEC quality-control laboratories tried to provoke such a discharge by cooling test CCDs down in weak vacuum conditions, but that proved to be impossible. Tape lifts had been taken from the flight-spare camera, and a large number of metallic and non-metallic particles were identified with a Scanning Electron Microscope (SEM) (Fig. 4). The failure symptoms were very closely reproduced by randomly shedding metallic particles of different sizes and shapes over the (uncoated) rear side of the CCD.

Figure 4. SEM images of a contaminant particle in XMM's p-n camera
