Lost in Space ?

- ESOC Always Comes to the Rescue

A. Smith, R. Muench, W. Wimmer, D. Heger,
X. Marc, F. Bosquillon de Freschville,
M. Rosengren, T. Morley, S. Pallaschke, B. Smeds,
C. Sollazzo & A. McDonald (Logica)
ESA Directorate of Technical and Operational
Support, ESOC, Darmstadt, Germany

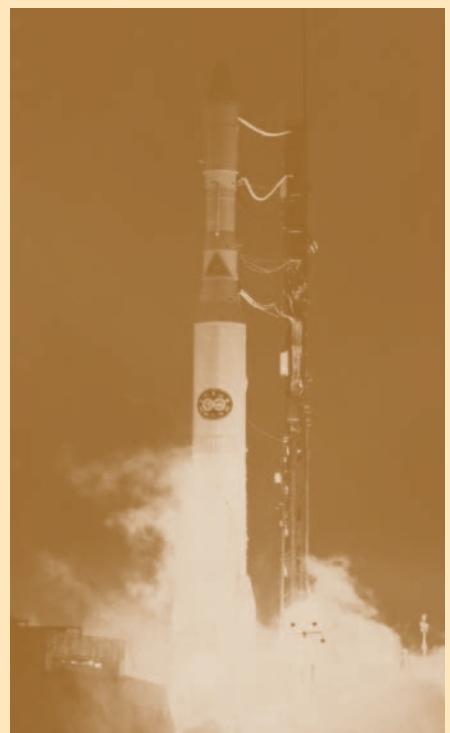
The launch of TD-1A from Western Test Range on 12 March 1972

On 12 March 1972, TD-1A, Europe's hitherto largest and most complex scientific satellite, was successfully launched from Western Test Range in California. It was ESRO's first astronomical satellite and it was to look at the stars with two telescopes. However, just a couple of months later, towards the end of May, both on-board tape recorders failed. As it was impossible to repair them, an appeal for help was put out.

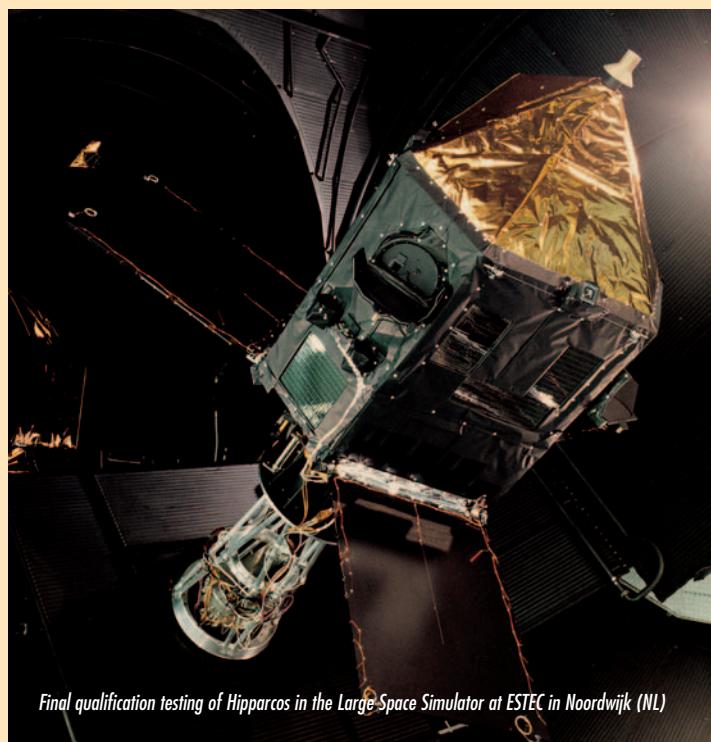
Final qualification testing of Hipparcos in the Large Space Simulator at ESTEC in Noordwijk (NL)

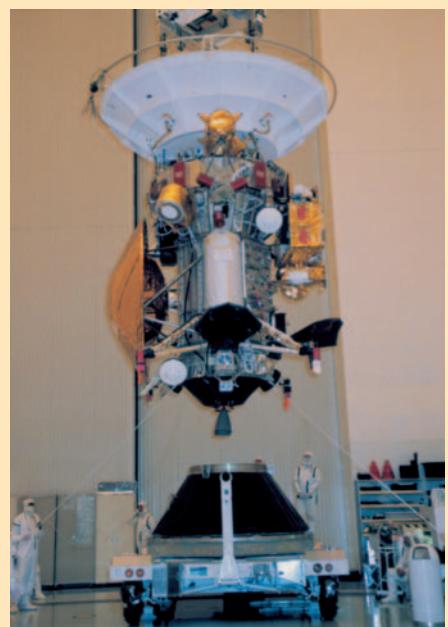
The Cassini spacecraft, with the Huygens probe mounted on the left side, being lowered onto its launch-vehicle adapter at Kennedy Space Centre (photo NASA)
