Carbon removal from trenches on EUV reticles

N.B. Koster^{a*}, C.P.E.C. Geluk^a, T.W. Versloot^b, J.P.B. Janssen^a, Y. Fleming^c, T. Wirtz^c
^aTNO, Stieltjesweg 1, 2628 CK Delft, The Netherlands; ^bESA, Keplerlaan 1, Noordwijk, The Netherlands; ^cDepartment “Science and Analysis of Materials” (SAM), Centre de Recherche Public – Gabriel Lippmann, 41 rue du Brill, L-4422 Belvaux, Luxembourg

Keywords: EUV reticles, cleaning, plasma, SIMS-SPM

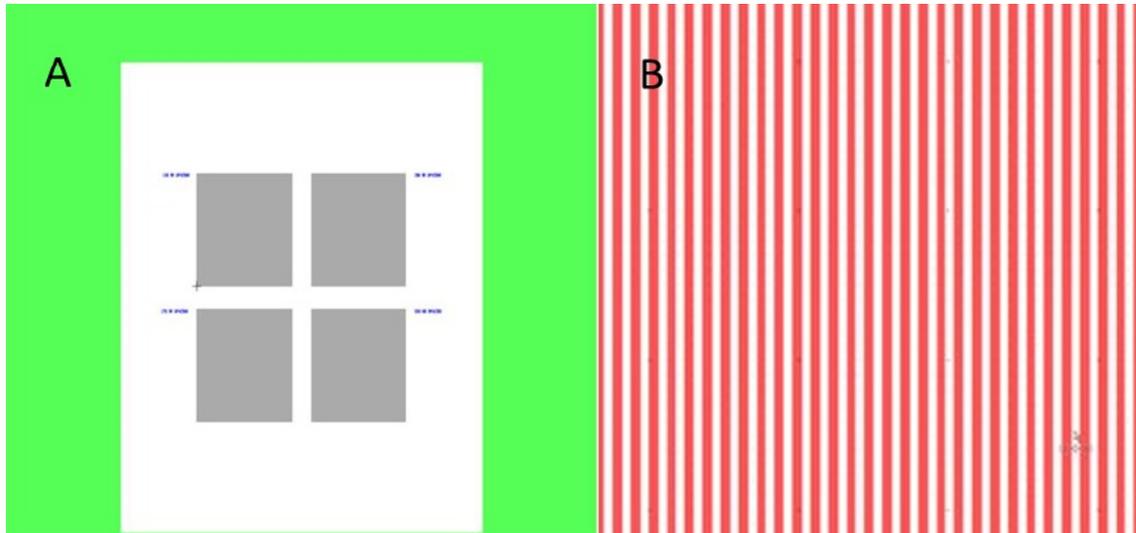
Figure 1: GDS drawing of the test structure, with a) full structure showing the four squares filled with lines and spaces and b) single structure with the lines and spaces.

As the availability of EUV reticles, which can be cut into pieces for analysis, is very scarce we made our own dummy structures on Si wafers. The test structure consists of dense lines and spaces arranged in a square as shown in **Figure 1**. One test structure consists of four smaller squares with different spacings, for this case we used 250, 300, 350 and 400 nm lines and spaces. Although this is not the dense spacing as can be expected on a real reticle we had to limit to these

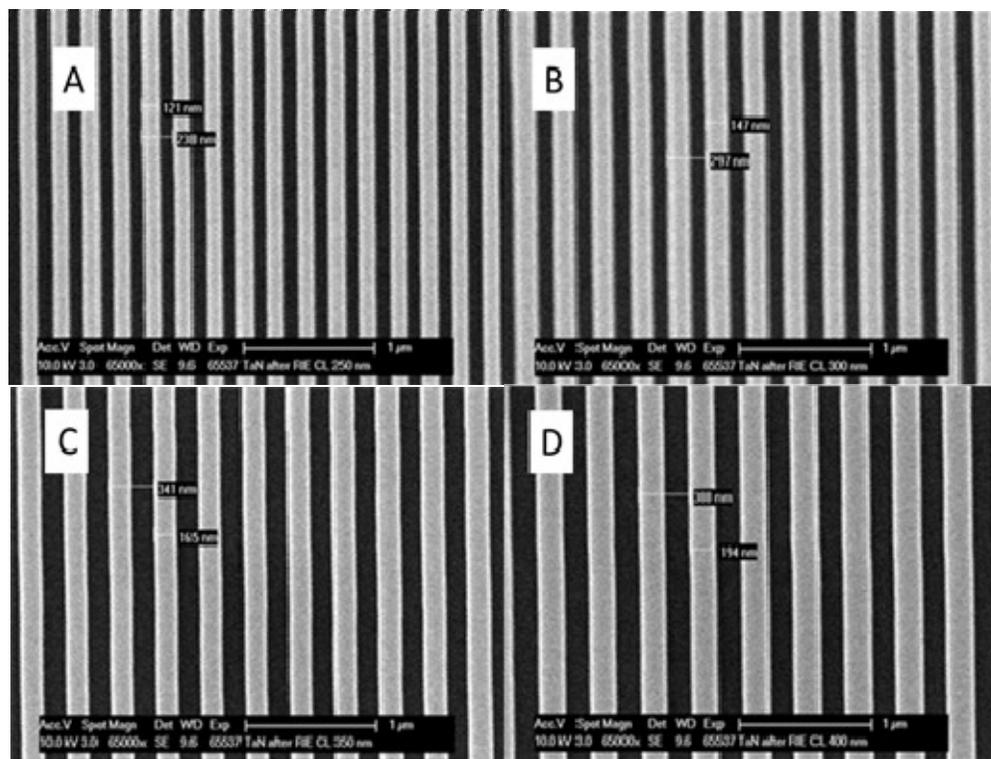
Figure 2: SEM images of the gratings after fabrication, dimensions are a) 238 nm, b) 297nm, c) 341 nm and d) 388 nm.

The structures were written in the resist with the aid of an e-beam pattern generator and developed. Finally the TaN was etched with RIE Chlorine plasma and the remaining part of the resist was stripped using a RIE Oxygen plasma. SEM-EDX analysis was used to verify the presence of TaN on lines and Ru in the trenches and the absence of carbon caused by possible remaining resist. SEM was also used to verify the dimensions of the gratings, see **Figure 2**, the measured dimensions for a line and space are: 238, 297, 341 and 388 nm.

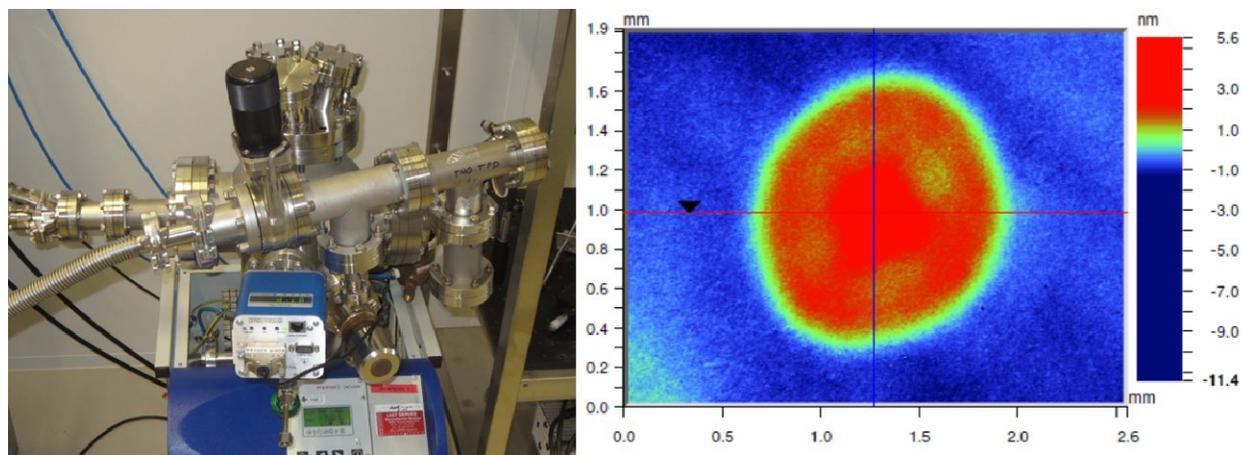
Figure 3: a) carbon growth setup with on the left side the e-gun b) typical profile of a grown carbon spot measured with interferometry.

After fabrication of the samples, the latter were contaminated with carbon using our carbon growth setup. This setup consists of an Ultra High Vacuum chamber equipped with a low energy e-gun from Kimball Physics and a gas supply for dodecane with a leak valve for setting pressure, see **Figure 3**. The samples are mounted in the vertical plane and alignment is verified using a fluorescent target. After focusing the e-gun produces a spot of about 1 mm^2 at an electron energy of 1 keV. An amorphous carbon layer is formed during illumination with a back ground pressure of $1 \cdot 10^{-6}$ mbar of dodecane. The growth rate of carbon in the setup is approximately 2 nm/hour and was verified with interferometry. The samples were exposed for 4 hours in the system leaving a carbon layer of approximately 10 nm. The focus does contain some hot spots and the carbon is not completely uniform. From previous experiments we have learned that if the carbon layer becomes relatively thick (>30 nm) the density increases in the bottom part of the layer and is harder to remove, therefore we limited ourselves to a layer of about 10 nm. In total 3 samples were prepared with an average carbon thickness of about 10 to 25 nm.

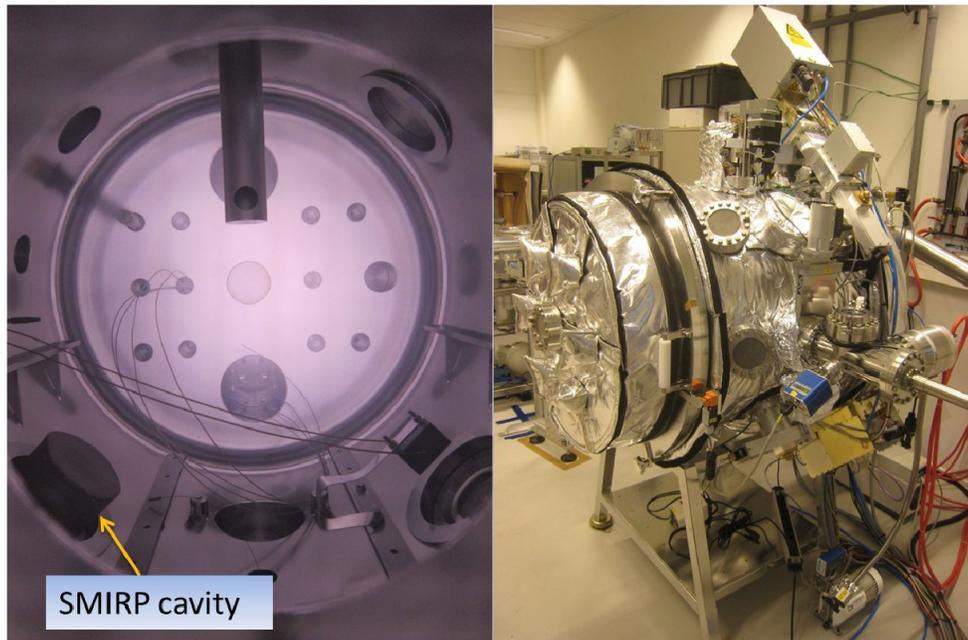
Figure 4: Plasma cleaner PATS with at the left side the interior showing a SMIRP cavity in the lower left corner.

After contamination with carbon two samples were cleaned to different degrees of cleanliness. For the cleaning our Plasma Analysis and Test Setup (PATS) was used, see **Figure 4**. The cleaning was performed using H_2 as active gas, settings for the source were 1000 W microwave power, 50% duty cycle with on pulse of 500 μs and a pressure of 0.2 mbar of H_2 . Samples were mounted at a distance of 6 cm from the source and the cleaning runs were time maximized to 15 - 30 min to prevent over heating of the sample. Sample DII-3/1 was cleaned for a total time of 30 min removing about 5 nm of the total contamination. Sample DII-3/5 was cleaned for a total cleaning time of 120 min, which should remove all of the contamination.

The PATS has a total of four MW sources capable of running simultaneously or in a timed pulsed mode. The last mode has the advantage of having a better penetration into small crevices and high aspect ratio trenches. For our experiments this mode was not used and only one source was used for the cleaning. The PATS has also capabilities of plasma

analysis with a Langmuir probe, retarding field analyzer and optical emission spectroscopy. For small samples a sample holder in the center of the chamber is available and at that position the sample can be monitored using a long focal length ellipsometer.

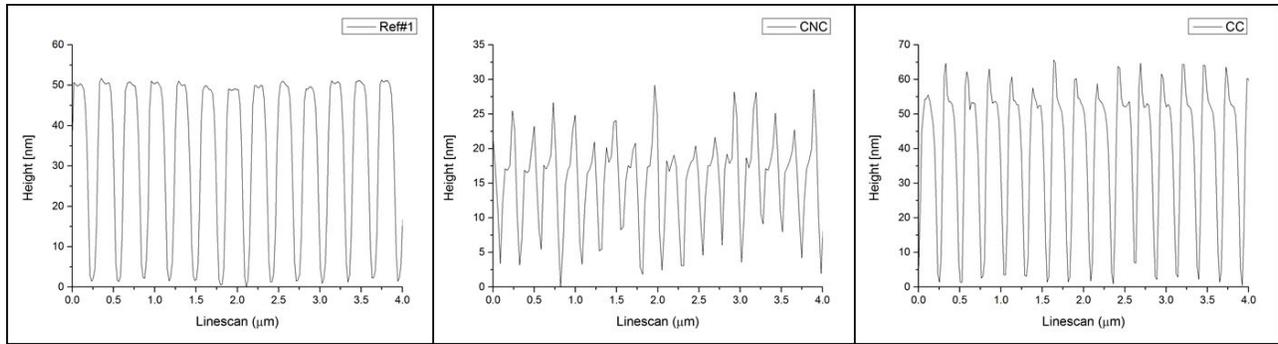
Figure 5: AFM line scans of the 300 nm lines and spacing structure of the reference sample, carbon coated sample (CNC) and fully cleaned sample (CC).

In **Figure 5** the AFM line scans are shown for the 3 samples (ref, contaminated and fully cleaned). The scans are taken on the structure with 300 nm lines and spaces. From the scan of the reference sample it can be observed that the bottom of the trench is not fully resolved by the AFM tip and that the height of the TaN layer is at least 50 nm and probably more. The line scan of sample DII-3/6 (CNC in figure) shows that the depth of the trenches has been greatly reduced to about 25 nm and that the top of the line has an added sharp feature. This indicates that the carbon layer has a much greater height than anticipated and that the trench is almost fully filled with carbon. The line scan of sample DII-3/5, which had been cleaned for full carbon removal, shows that the depth of the trench has been restored to at least 50 nm. The top of the line still shows a remainder of the features that were clearly visible in the carbon coated sample. This again indicates that not all carbon was removed and that the layer is thicker than anticipated.

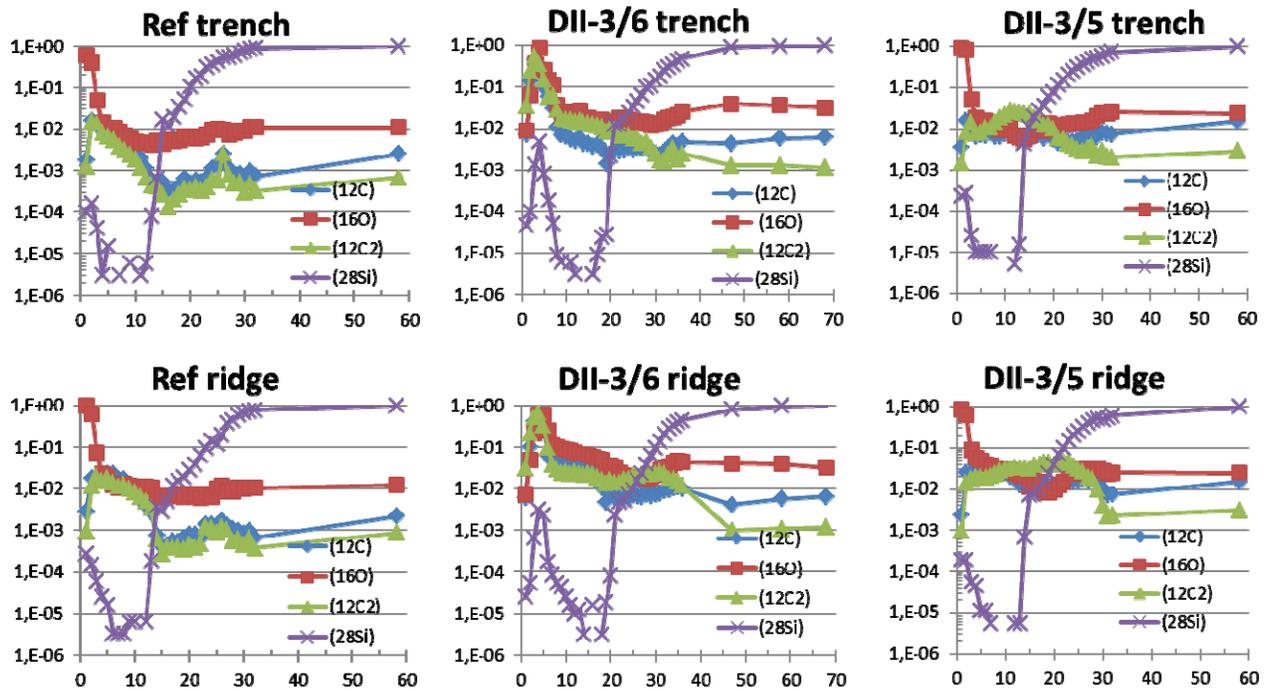
Figure 6: SIMS depth profiles of the reference sample (Ref), the contaminated sample (DII-3/6) and the cleaned sample (DII-3/5) for the trench and the lines (ridge). In all figures, the detected secondary ion signals were normalized to the average Si- bulk signal. The detection of the TaN- signal was only limited and is not shown. The horizontal axis is the number of the raster slice.

Figure 6 shows the sputter depth profiles of the three analyzed samples. On all samples the depth profile was determined on top of the line (ridge) and in the bottom of the trench. For each profile several slices were executed until the Si wafer substrate was reached. This takes typically 30 slices before the Si signal stabilizes and all the C, TaN and Ru has been sputtered away.

The reference sample shows some oxygen on top of the surface, both in the trench as in the ridge, it takes about 12 slices before the Si starts to show up in the SIMS spectra and with 30 slices the Si starts to peak indicating that the wafer has been reached by the sputter gun. The contaminated sample clearly shows carbon on top of the surface and it takes about 6 slices to cut through the carbon layer. It is interesting to see that the Si signal of the contaminated sample spikes together with the carbon peak. The completely cleaned sample shows a restored spectrum when compared to the reference, with a similar number of slices needed to reach the wafer. Also the oxygen peak on the surface has been restored and the Si peak which is visible in the contaminated sample in the first slices has disappeared. The carbon signal
